## Cocksburn Reservoir/Dumyat Footpath Works – Environmental Clerk of Works Report

**Author** James Bunyan, Tracks Ecology Tel: 07528865557 Email: info@tracksecology.com  
**Report No. - Week commencing** 12 – 02/04/2018  
**Site visit** 04/04/2018  
**Weather during visit** Heavy blizzards, strong winds and lying snow  
**Report Issued** 04/04/2018

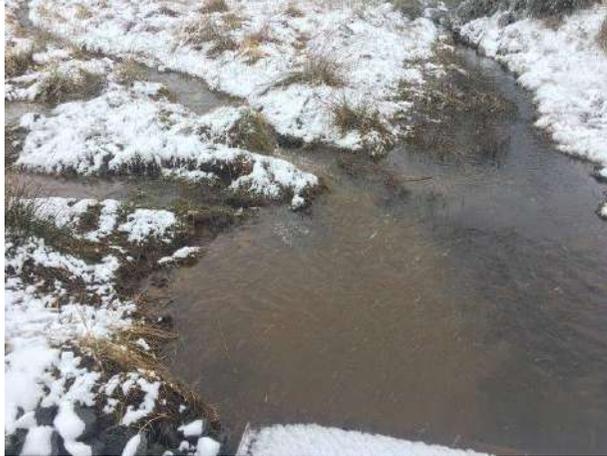
<b>New ECoW Observations</b>					
<b>Ref</b>	<b>Site Area</b>	<b>Category</b>	<b>Details</b>	<b>Recommendations</b>	<b>Importance</b>
12.1	Cocksburn/ Compound	Drainage/ Silt	Silty water was observed entering the Cocksburn Reservoir via the eastern tributary of the Cocks Burn which flows under Sheriffmuir Road close to the Site compound. Source of dirty water was identified as coming from two locations. 1 – Section of ditching works approximately 400m north of the compound along Sheriffmuir Road, and 2 – small volumes of dirty water draining out of entrance to compound and passing over road and into eastern roadside ditch which then flows into burn.	Issue inspected with SPEN and later with McGowans. 1 - McGowans confirmed that urgent ditching work was undertaken on morning of 4 <sup>th</sup> April as a culvert was blocked pushing majority of ditch water onto road north of compound resulting in significant surface water on public road. Ditching works therefore resulted in short period of silt input to ditch. Further investigations of blocked roadside culvert to be undertaken during more favourable weather conditions. On completion of site visit this water was beginning to run clean again. 2 - Additional silt mitigation within the compound was discussed and a small ditch was extended to catch surface water drainage from hardstanding with additional sumps installed adjacent to entrance gate to improve dirty water management. Options for further silt control in this area are limited but issue requires monitoring to identify whether or not further measures are required.	High

12.1 Mixing of dirty and clean tributaries of Cocks Burn.

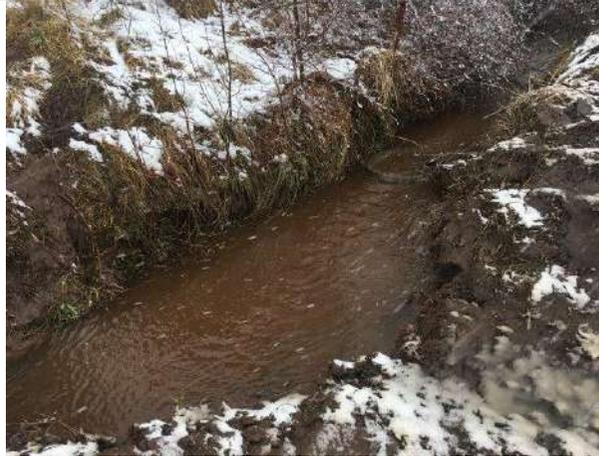
12.1 Dirty water originating at location of ditching works north of compound.

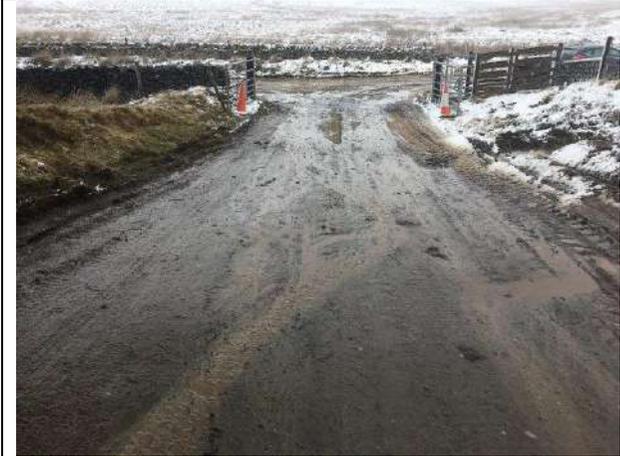
12.1 Small volumes of dirty water run off from compound.

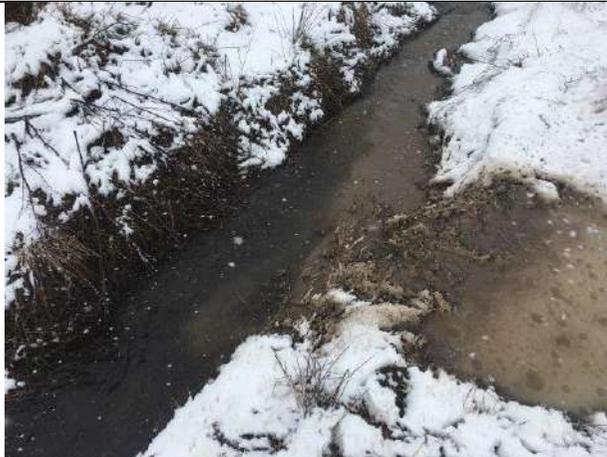
12.1 Dirty water runoff from compound reaching roadside ditch and burn.

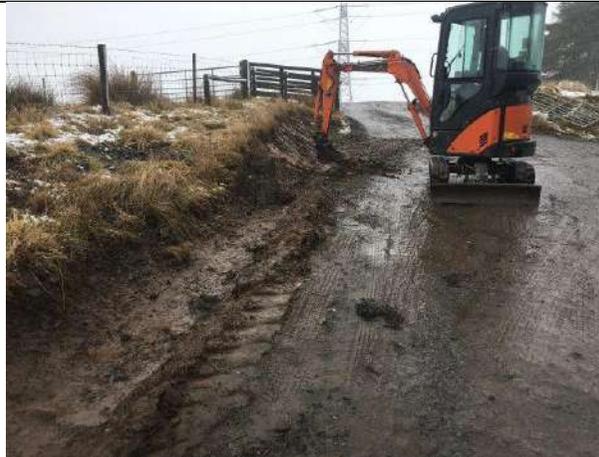
12.1 Mitigation work underway soon after issue identified. Aim to catch majority of surface run off within compound and direct to existing and new sump.

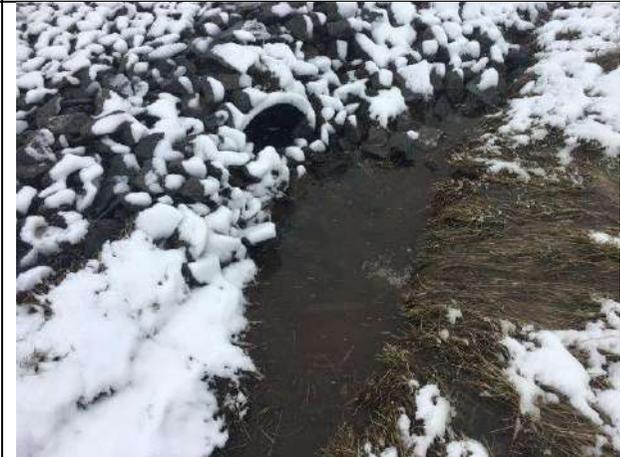
12.2	Cocksburn	Drainage/ Silt	Culvert entrance is partially blocked with sub-base material potentially reducing effectiveness of drainage.	Clear culvert entrance to ensure culvert remains effective.	Low

12.2 Partially blocked culvert, reducing effectiveness of drainage.
