## Cocksburn Reservoir/Dumyat Footpath Works – Environmental Clerk of Works Report

**Author** James Bunyan, Tracks Ecology Tel: 07528865557 Email: info@tracksecology.com  
**Report No. - Week commencing** 14 – 16/04/2018  
**Site visit** 16/04/2018  
**Weather during visit** Mild and dry.  
**Report Issued** 16/04/2018

# Cocksburn Reservoir and Dumyat Footpath Works

ECoW Visit 14 - 16/04/2018

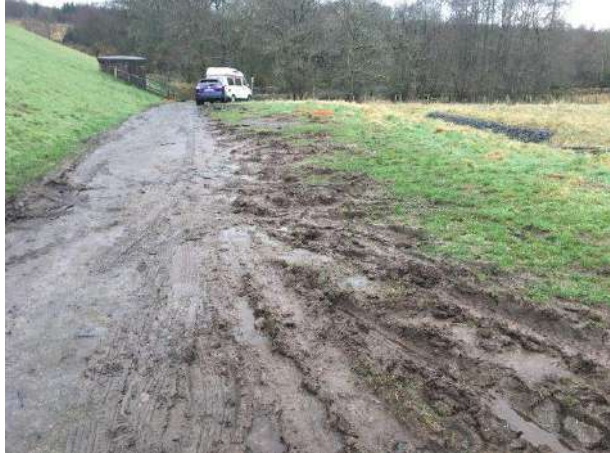
<b>New ECoW Observations</b>					
<b>Ref</b>	<b>Site Area</b>	<b>Category</b>	<b>Details</b>	<b>Recommendations</b>	<b>Importance</b>
14.1	Cocksburn	Sensitive Habitats/Species	Section of wet grassland east of reservoir dam has been significantly disturbed by vehicles.	This is unrelated to McGowans work and is assumed to be as a result of members of the public using the location for parking. Included within this report as a record.	Low

14.1 Disturbed ground at eastern end of reservoir.

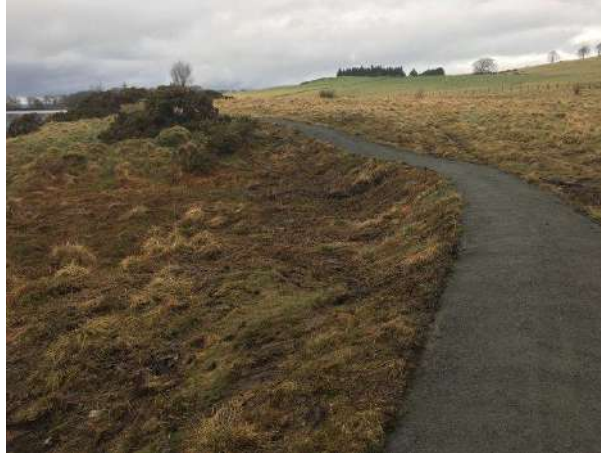
High quality reinstatement along Cocksburn Reservoir.

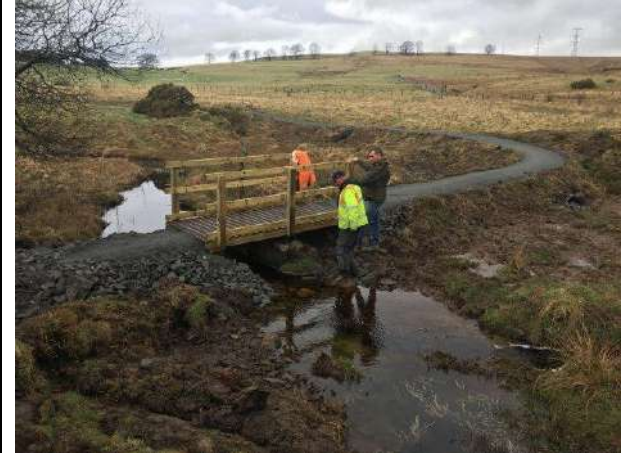
Bridge installation complete including high flow side channel.

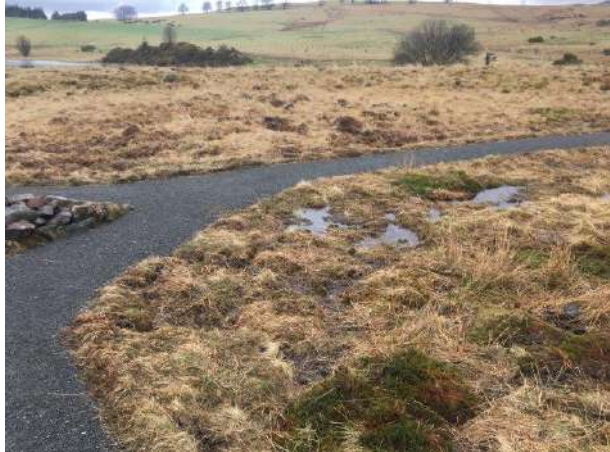
Location of standing water to be managed through additional culvert installation.

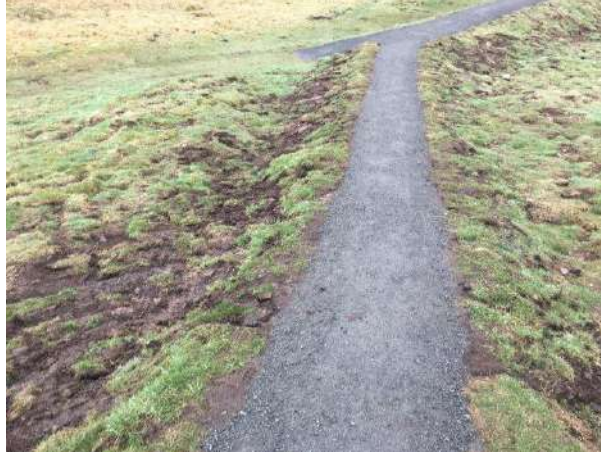
14.2	Dumyat	Sensitive Habitats/Species	Reinstatement has been slightly impacted upon by movement of cattle across sections of path – particularly within Section 9.	Although disturbance is not extensive, it is noted that some impact on reinstatement has been caused and is not easily controlled. Ad hoc repairs have been undertaken but further disturbance is possible. Issue likely to become less of an issue as reinstatement becomes settled.	Low

14.2 Some impacts on reinstatement on Dumyat from cattle.

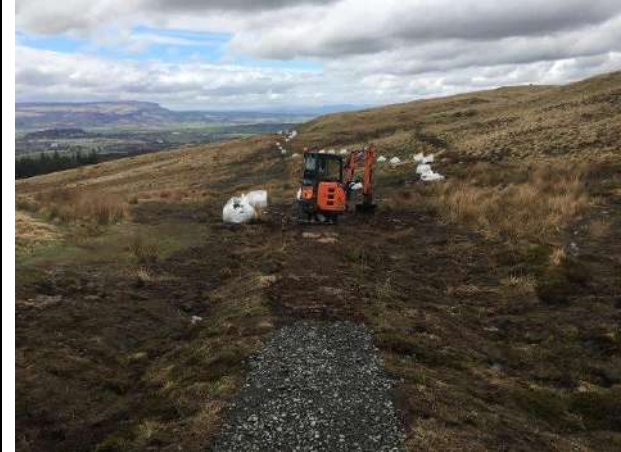
14.3	Dumyat	Sensitive Habitats/Species	Works along Section 6 is now underway and particular care is required to limit impacts on GWDTEs.	Discussions between McGowans and ECoW were undertaken during site visit, with approach agreed. In summary line of path is to avoid significant area of potential GWDTEs. Where crossing such habitats, localised flushed areas will be avoided with appropriate water management (culvert with diffuse outfall) will be sensitively installed. Extensive ditching will be avoided in sensitive areas to avoid any significant changes in hydrological connectivity. Culvert locations discussed and agreed. Path construction and water management to be monitored for effectiveness. Works are in line with those proposed on Tracks Ecology Drawing 18/001/MCG/004 GWDTE Mitigation.	Moderate

14.3 Start of Section 6 under construction.
