Cocksburn Reservoir/Dumyat Footpath Works – Environmental Clerk of Works Report

Author James Bunyan, Tracks Ecology Tel: 07528865557 Email: info@tracksecology.com
Report No. - Week commencing 15 – 23/04/2018
Site visit 23/04/2018
Weather during visit Mild with light showers and gusty wind.
Report Issued 24/04/2018

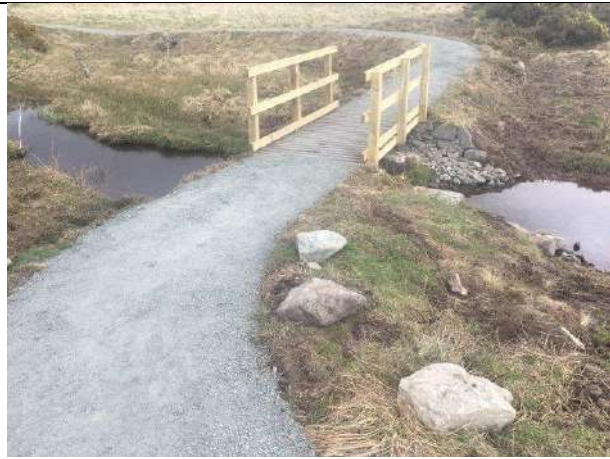
Bridge installation and good reinstatement

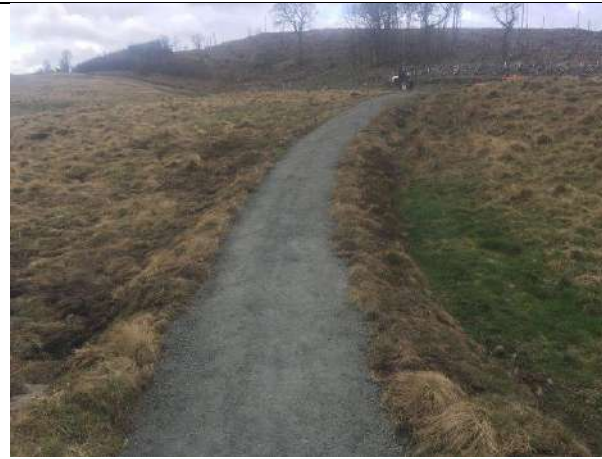
11.1 Section cleared of material and reinstated

Recently Closed ECoW Observations					
Ref	Site Area	Category	Details	Notes	Closed
11.1	Cocksburn	Habitats	Storage of top layer material has mixed with adjacent turves, making reinstatement more difficult.	<p>Ensure that turves are not contaminated with stored materials. Ensure that as much material as possible is removed from turves and adjacent habitat as is possible during reinstatement.</p> <p>04/04/2018 – Issue noted by McGowans and area is to be tidied and reinstated as soon as weather allows.</p> <p>10/04/2018 – Reinstatement of area has not been undertaken to date but will be completed as section of path is reinstated to avoid further double handling of material.</p> <p>16/04/2018 – Majority of stored material now removed and reinstatement works along section likely in coming days.</p> <p>23/04/2018 – Area has been reinstated well.</p>	23/04/2018

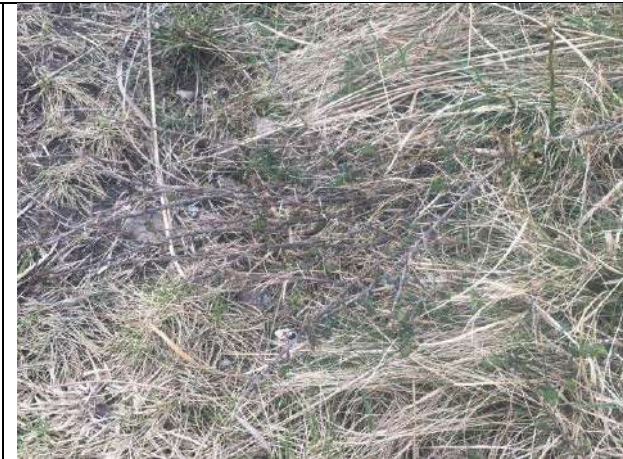
Petty whin coming into leaf

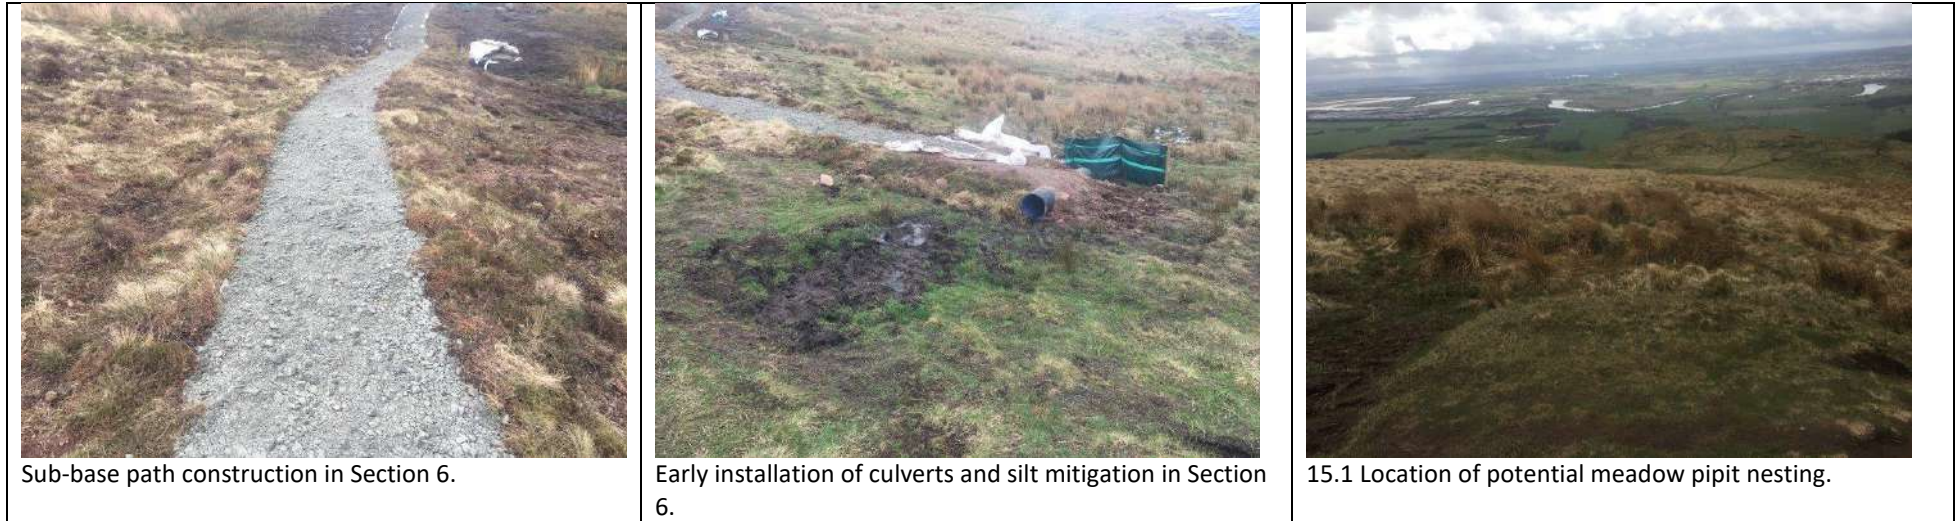
New ECoW Observations					
Ref	Site Area	Category	Details	Recommendations	Importance
15.1	Dumyat	Protected Species	Potential nesting meadow pipits approximately 20m south of line of path at end of Section 6.	At present potential nesting location is far enough away from works corridor, especially considering the path is relatively busy. No additional mitigation required, but vigilance by workforce is required. If concerns arise then workers should minimise the amount of time spent outside of machines in areas of concern. Communications with ECoW should be undertaken if nests within 20m of working corridor are suspected.	Moderate

Sub-base path construction in Section 6.

Early installation of culverts and silt mitigation in Section 6.

15.1 Location of potential meadow pipit nesting.

Ongoing ECoW Observations					
Ref	Site Area	Category	Details	Ongoing Notes	Importance
14.3	Dumyat	Sensitive Habitats/Species	Works along Section 6 is now underway and particular care is required to limit impacts on GWDTEs.	Discussions between McGowans and ECoW were undertaken during site visit, with approach agreed. In summary line of path is to avoid significant area of potential GWDTEs. Where crossing such habitats, localised flushed areas will be avoided with appropriate water management (culvert with diffuse outfall) will be sensitively installed. Extensive ditching will be avoided in sensitive areas to avoid any significant changes in hydrological connectivity. Culvert locations discussed and agreed. Path construction and water management to be monitored for effectiveness. Works are in line with those proposed on Tracks Ecology Drawing 18/001/MCG/004 GWDTE Mitigation. 23/04/2018 – Care is being taken around GWDTEs areas with works suspended during wet weather to limit disturbance. Footprint of works is being kept to a minimum with early	Moderate

installation of culverts and use of silt fences resulting in no silt issues arising. Area to be monitored with continuation of existing sensitive working practices.	
--	--	--	--	--	--
