Cocksburn Reservoir/Dumyat Footpath Works – Environmental Clerk of Works Report

Author James Bunyan, Tracks Ecology Tel: 07528865557 Email: info@tracksecology.com
Report No. - Week commencing 16 – 30/04/2018
Site visit 02/05/2018
Weather during visit Mild and dry.
Report Issued 03/05/2018

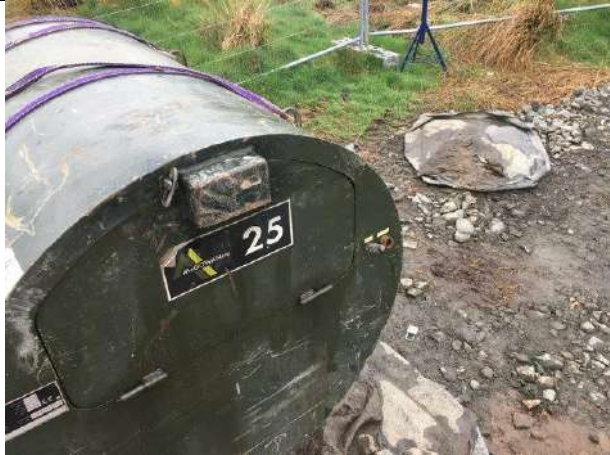
New ECoW Observations					
Ref	Site Area	Category	Details	Recommendations	Importance
16.1	Cocksburn	Pollution Risk	Fuel bowser at Cocksburn compound was unlocked with no staff present.	Fuel store should be kept locked at all times when not in use, especially in light of recent issues with tampering of equipment.	Moderate

16.1 Fuel bowser not locked and unattended.

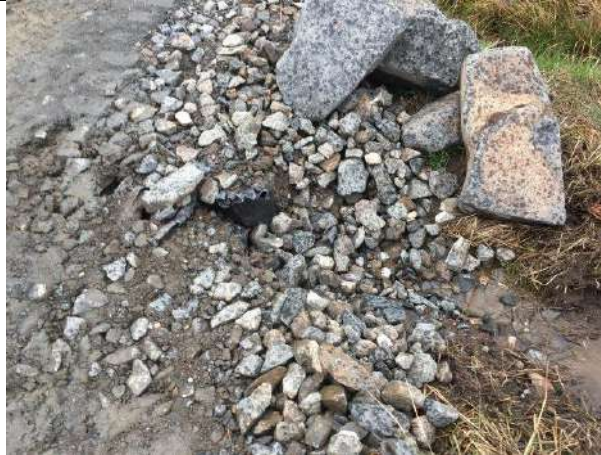
16.2	Cocksburn	Drainage	Damaged culvert outfall near Cocksburn compound resulting in partial blocking of culvert.	Area can be repaired during reinstatement works to be undertaken in next few days.	Low

16.2 Damaged culvert near Cocksburn compound.

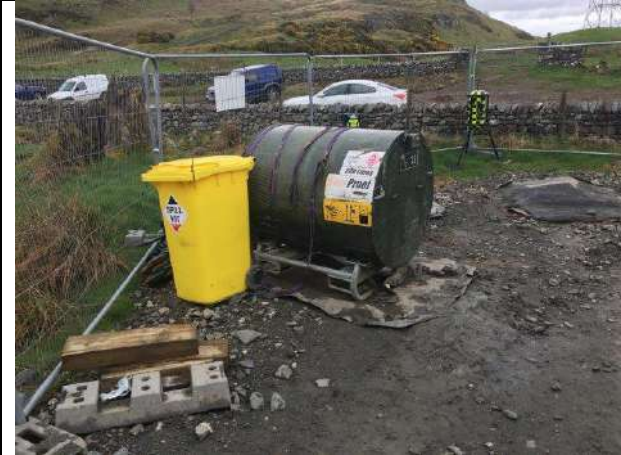
16.3	Cocksburn and Dumyat	Pollution Risk	Some of the plant nappies have become heavily soiled and their effectiveness may be reduced.	Consider replacing any plant nappies to ensure effectiveness.	Moderate

16.3 Plant nappy with reduced effectiveness.

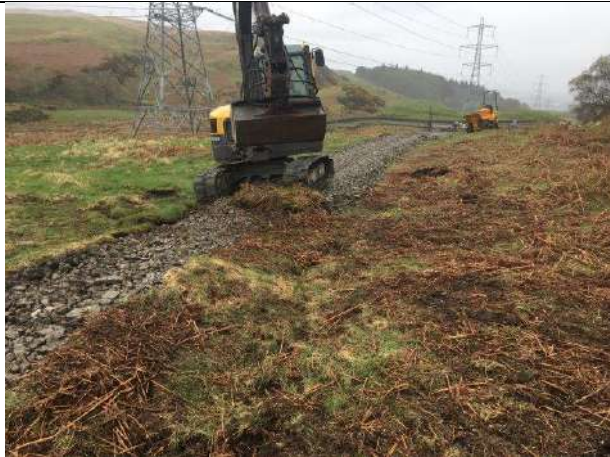
Continuation of good reinstatement along Cocksburn.

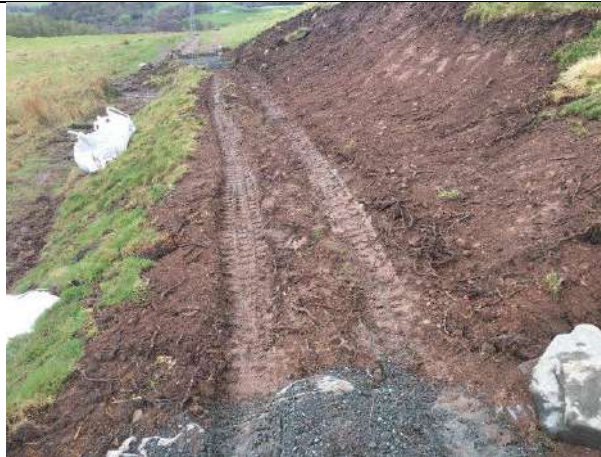
16.4	Dumyat	Sensitive Habitats/Species	Small area of steep slope has been cut away on lower section of Section 6 to allow path bed to be created. Due to the angle of the slope it will be difficult to get reinstated turves to establish. In addition reinstated turves in places support gaps which may allow edges of turves to dry resulting in shrinkage, erosion and failure to establish.	Suggested use of some of the boulders present to form natural looking ledges and then some degree of reinstatement where possible to create natural look. Also potential to expose bedrock in areas discussed. Key will be to obtain natural looking feature with no potential for erosion. Ensure that as far as possible no gaps between reinstated turves remain. Gaps may need filling with soils to ensure that a tight surface is present preventing drying by wind.	Low

16.4 Section of steep slope which will be difficult to revegetate.

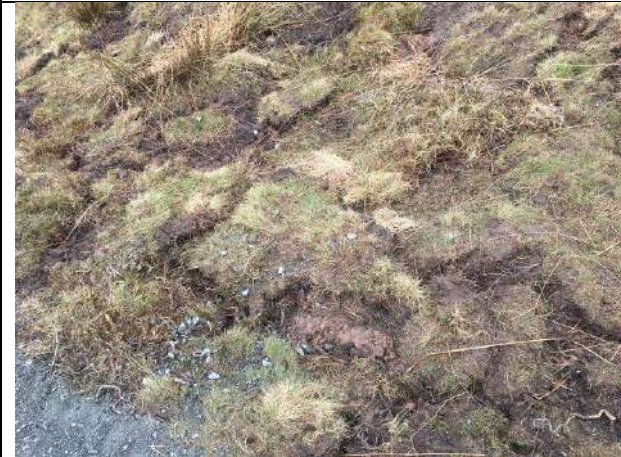
16.4 Section of reinstatement that risks drying out due to gaps between short sward turves.

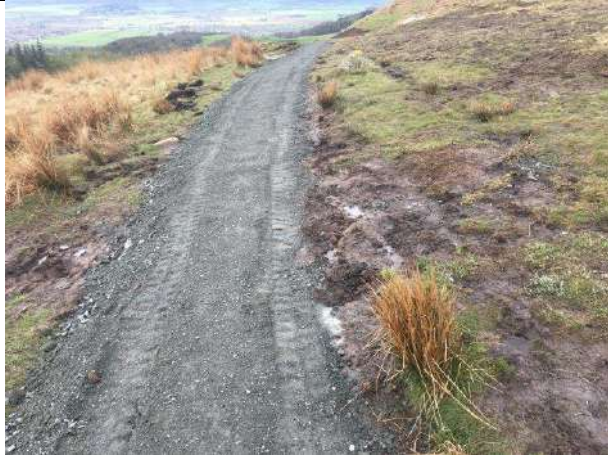
16.5	Dumyat	Drainage	Close to the temporary compound on Section 6 a small area of impeded drainage and subsequent standing water is present immediately adjacent to the path.	Additional drainage management required at location. Ensure that whichever approach is taken additional drainage of GWDTE areas is not facilitated.	Low

16.5 Section of wet ground that requires drainage management.
