Cocksburn Reservoir/Dumyat Footpath Works – Environmental Clerk of Works Report

Author James Bunyan, Tracks Ecology Tel: 07528865557 Email: info@tracksecology.com
Report No. - Week commencing 11 – 26/03/2018
Site visit 30/03/2018
Weather during visit Dry, cool with gusty wind
Report Issued 02/04/2018

Cocksburn Reservoir and Dumyat Footpath Works

ECoW Visit 11 - 30/03/2018

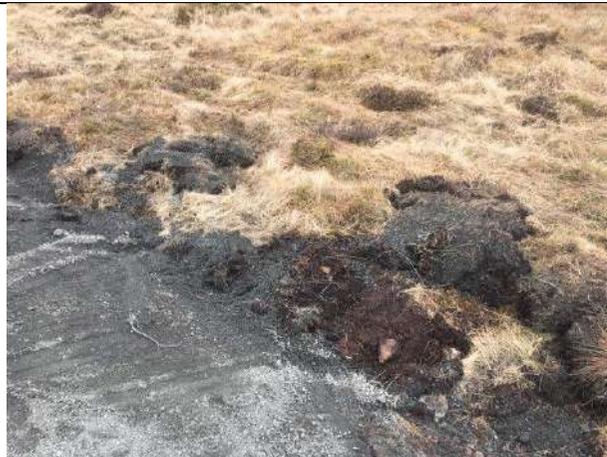
New ECoW Observations					
Ref	Site Area	Category	Details	Recommendations	Importance
11.1	Cocksburn	Habitats	Storage of top layer material has mixed with adjacent turves, making reinstatement more difficult.	Ensure that turves are not contaminated with stored materials. Ensure that as much material as possible is removed from turves and adjacent habitat as is possible during reinstatement.	Moderate

11.1 – top layer material mixing with turves and habitat

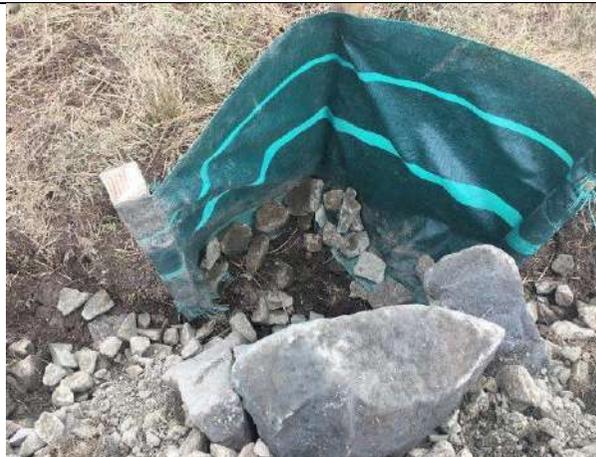
11.2	Cocksburn	Drainage/ Silt	Silt fence installation not correct, bottom edge of one silt fence just weighted down with rocks.	This silt fence will be ineffective and should have the bottom edge dug into the ground as per best practice installation.	Moderate

11.2 Poorly installed silt fence.

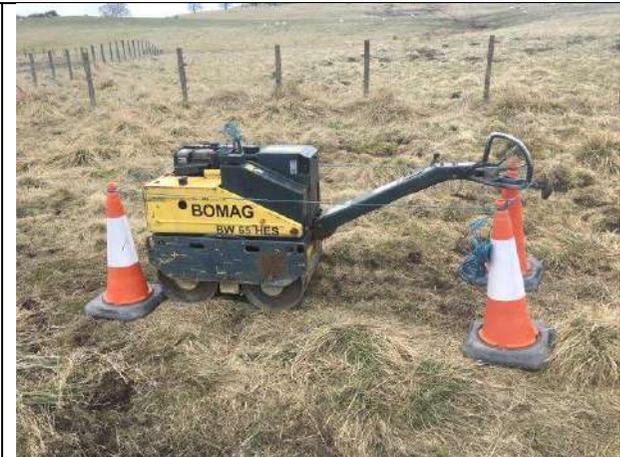
11.3	Cocksburn	Sensitive Habitats	Vibrating roller stored on grassland habitats adjacent to path.	Ideally all plant should not be stored on semi-natural habitats if it can be avoided. It is appreciated that path should not be blocked, but if possible roller should be tracked back to area of wider incomplete path sections.	Low

11.3 Where possible avoid storage of plant on habitats.
